Case 275 : Narrative

Case Vehicle (A): 2000 Mercury	Vehicle (B): 1993 Dodge
Type: Cougar, 3-door coupe	Type: Intrepid, 4-door sedan
Driver: 21-year-old female	Driver: 39-year-old female
CDC: 12-FLEE-5	CDC: 99-0000-0

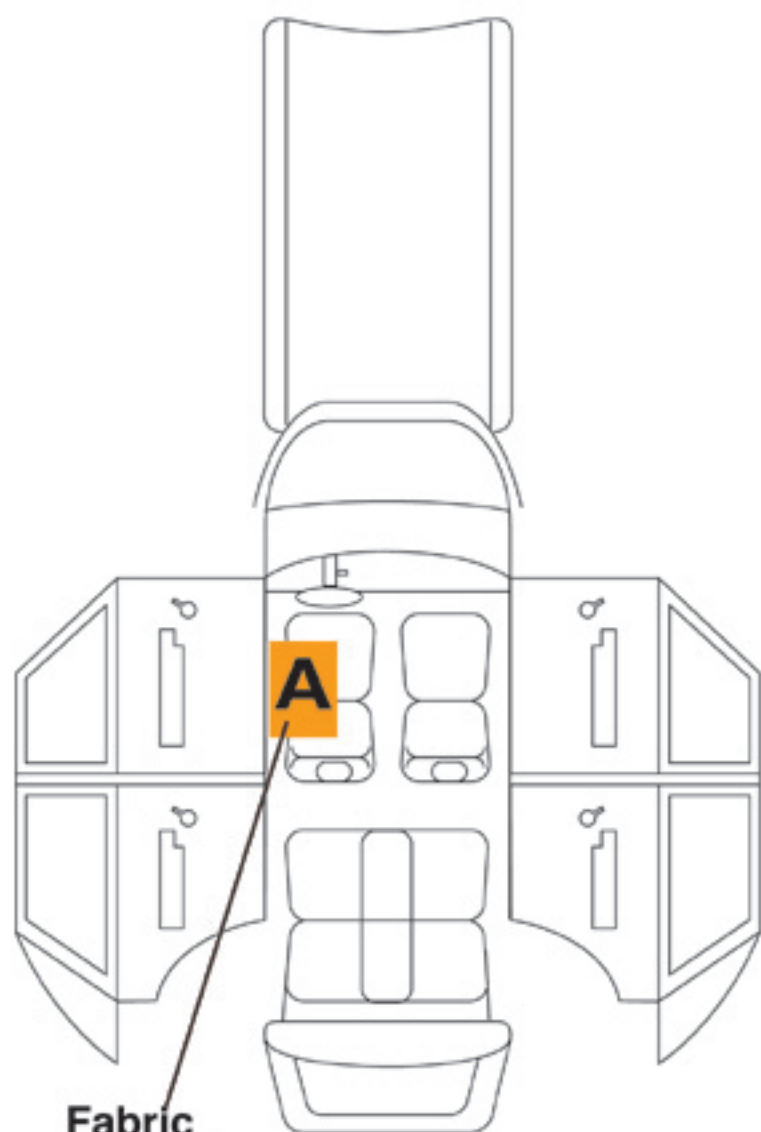
Fabric
creased

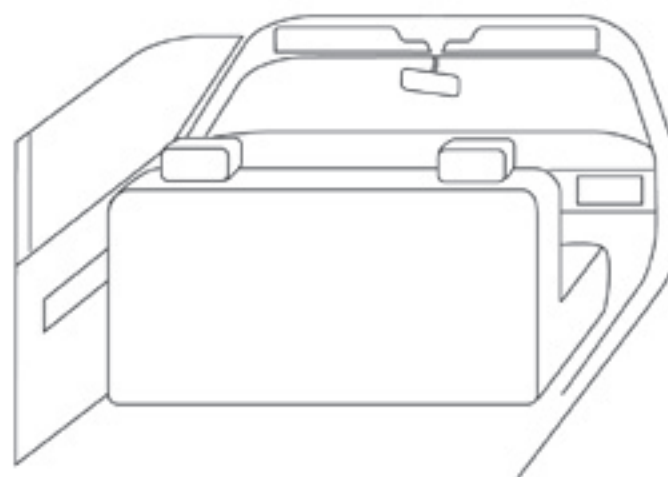
Blood smear

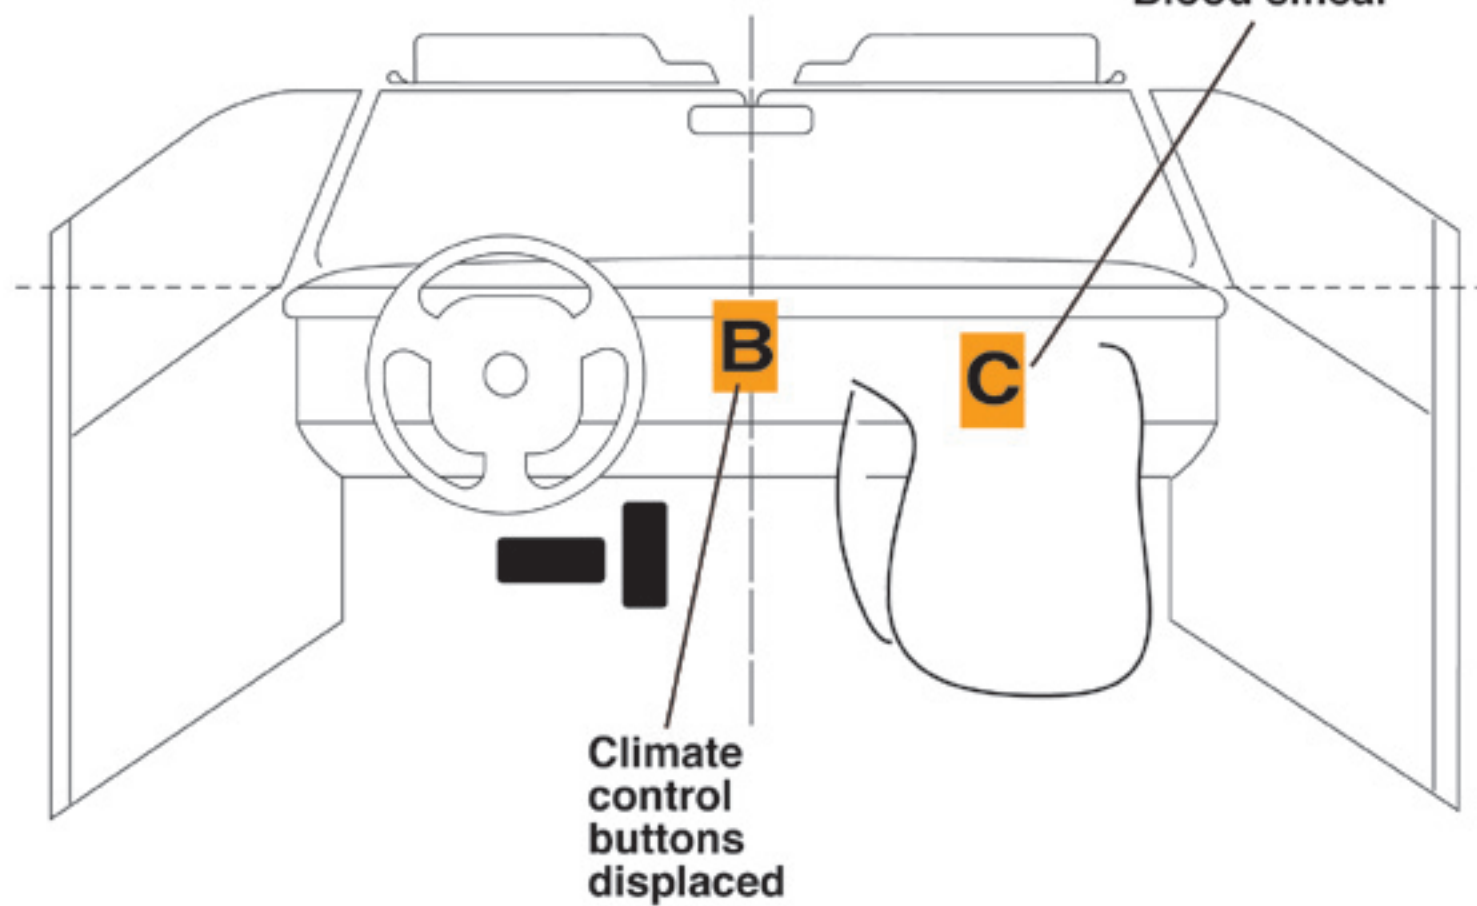
Climate
control
buttons
displaced
